TRP2

LET MALLATITE HELP YOU TO PROTECT THE PUBLIC WITH TRP2

Prevent lighting columns collapsing from base corrosion

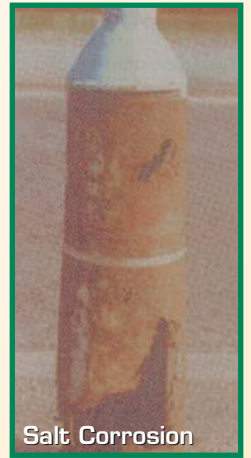
Invariably when street lighting columns collapse it is due to base corrosion at, or near, the groundline. Corrosion can be internal as well as external. Acid soils, road de-icing salt, dog urine, acid rain, chemical weed killers as well as acid condensates from vehicle exhaust fumes, all cause ground-water contamination which leads to rapid corrosion unless the root is adequately protected.

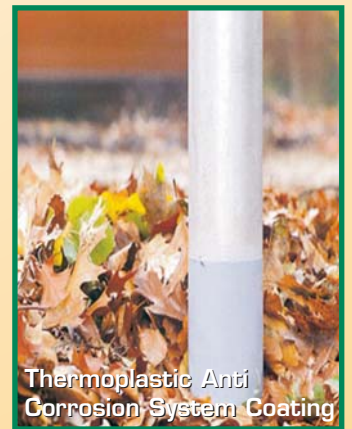
Recently MALLATITE has made a massive investment in an automated plant, which Thermoplastic Anti Corrosion System coats the outside of a column root to the height of planting depth + 250mm, internal coating is optional.

This THERMOPLASTIC ROOT PROTECTION system, which gives TOTAL root protection, is particularly suitable for those not wishing to go to the expense of a totally coated column and who are satisfied with either a galvanised or painted finish for the rest of the column. For those who usually insist on additional metal thickness in the base of a column to safely allow for the corrosion, this double coating makes the additional expenditure for the heavier column unnecessary and, in some cases, the over all cost of the column can be lower with TRP² finish.
